## DAB R&S Tx issue

Root cause of this issue is incompatibility between R&S and Frauenhofer related to handling and setting of the ETI Header Error Level.

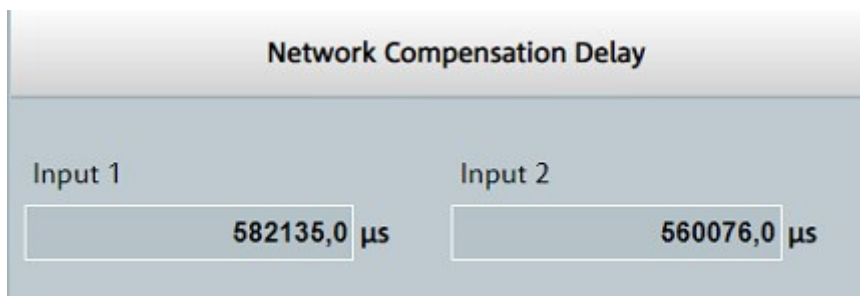
It seems like "Tx Delay" must be set to the average of Network Compensation Delays monitored here:

Static Delay is here set to the same value as for my transmitters in the Rogaland-area. This is just a value for compensating for extra delay created with Gates Air Transmitters compared to the other transmitters we are using. It should not have any affect on SFN lock (In Time), but I used it just as a test, and this seems to work?

I watched SFN-state for about 10 minutes with no resyncs, warnings or errors, so is this now working????

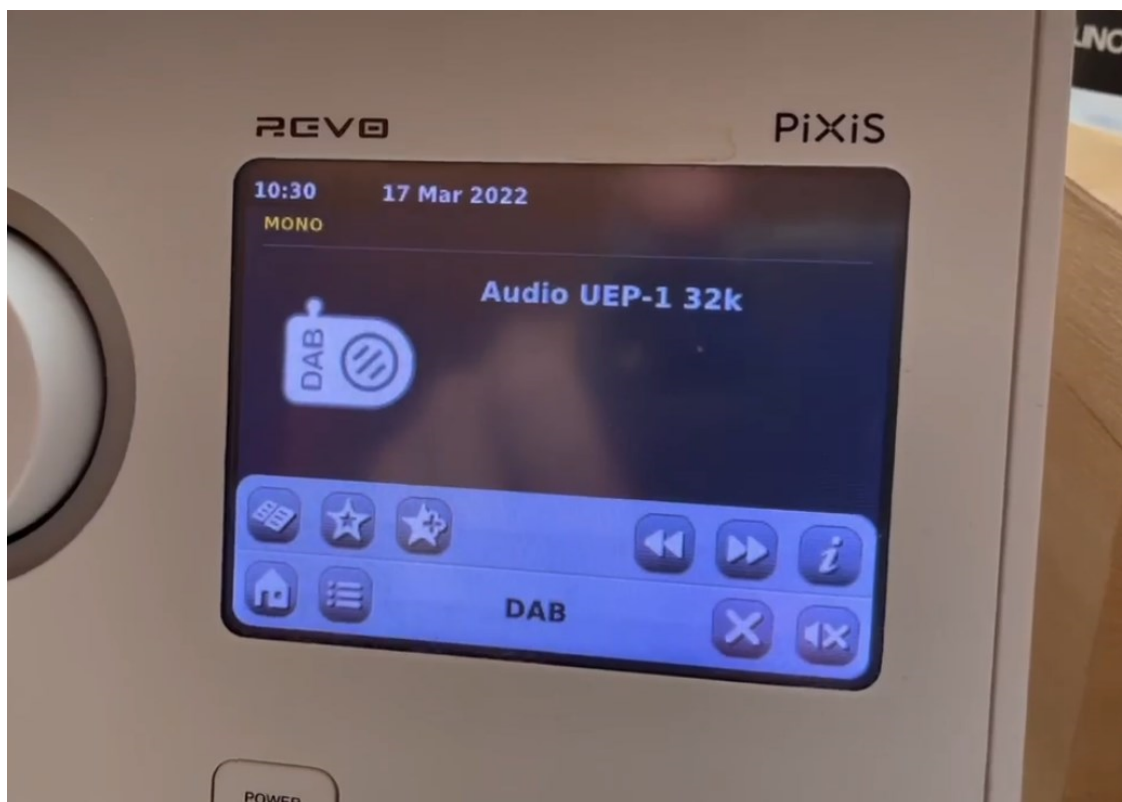
La oss håpe det, men jeg har mine tvil. Kan det være at senderen står i "test-modus"? Bernhard Ingebrigtsen fortalte meg for en tid tilbake at han fikk inn noe som lignet et testsignal på sine DAB-mottakere (uten lyd).

**Det er ingen kanaler som sender UEP1 32k fra oss, så den kanalen må komme fra senderen og ikke oss. Jeg tror det samme sendes ut enda!?**
